Bend failure mechanism of high-strength steel

Efficient and effective root cause analysis using the Axia ChemiSEM

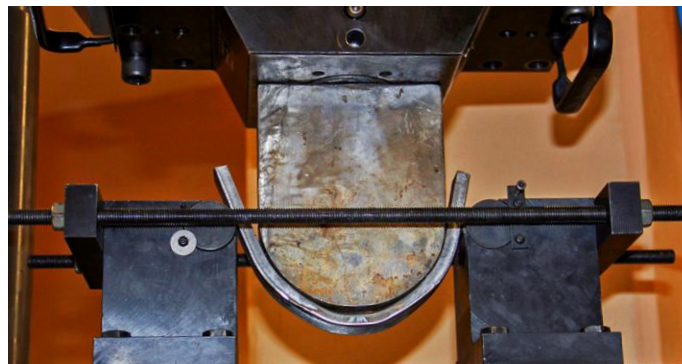
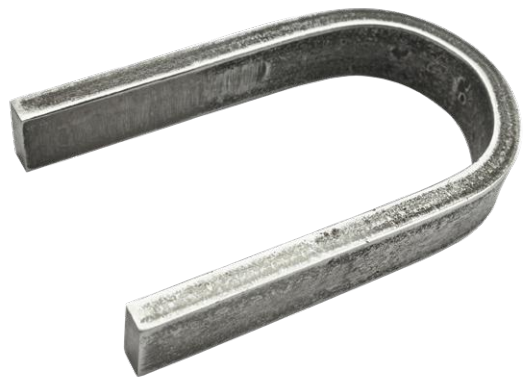
Figure 1. Bend test (top) and tested piece (bottom).

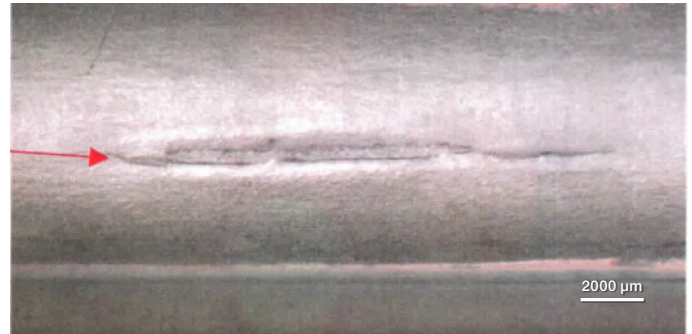
Figure 2. Image of a failed bend test.

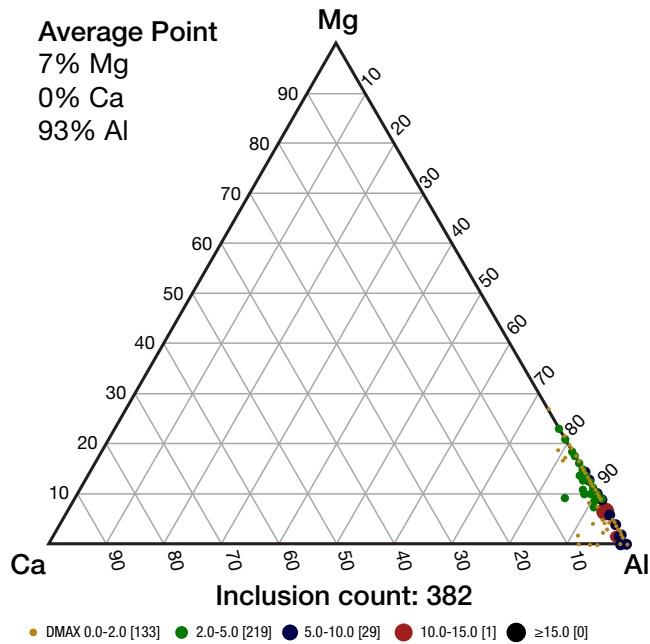
During refining and casting, the pure aluminum oxide inclusions may become contaminated with magnesia, calcia, or slag droplets. Figure 3 shows the Ca-Al-Mg ternary diagram of oxide inclusions analyzed in the steel near the bend test defect, which has been run by a Thermo Scientific™ Phenom™ ParticleX Steel Desktop SEM thresholding the features greater than 1 μm.

Figure 3. Base inclusion analysis was collected on this sample by the Phenom ParticleX Steel Desktop SEM.

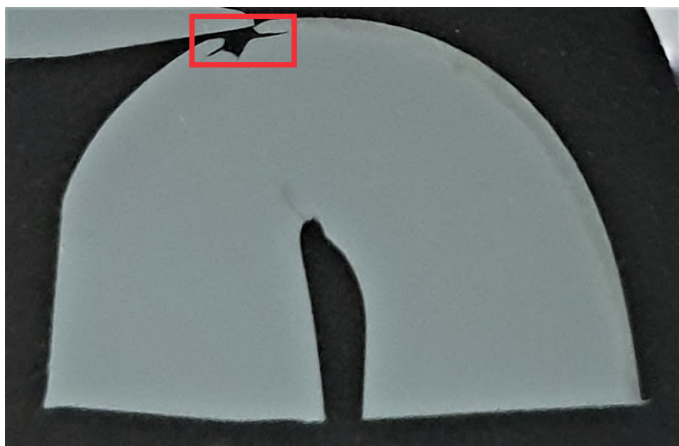
The sample of interest is HSLA hot-rolled steel that failed during a bend test. Different cross sections of the fractured sample (Figure 4) were observed using an Axia ChemiSEM.

Figure 4. Cross section of a bend tested steel. The crack, propagated on the outer radius, is highlighted in red.

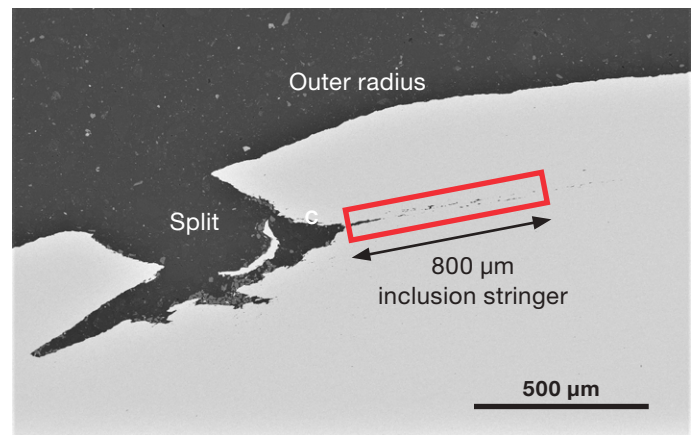
Figure 5. Backscattered electron image of the split. Highlighted area is the inclusion stringer that started at the base of the split (Acc voltage 15 keV, beam current 0.22 nA).

The split on the outer radius opens to a depth of approximately 400 microns. At the base of the split, an inclusion stringer can be observed (Figure 5, in red) extending into the metal at the same depth. To understand the nature of the inclusions within the stringer, further higher magnification images and ChemiSEM maps were acquired.

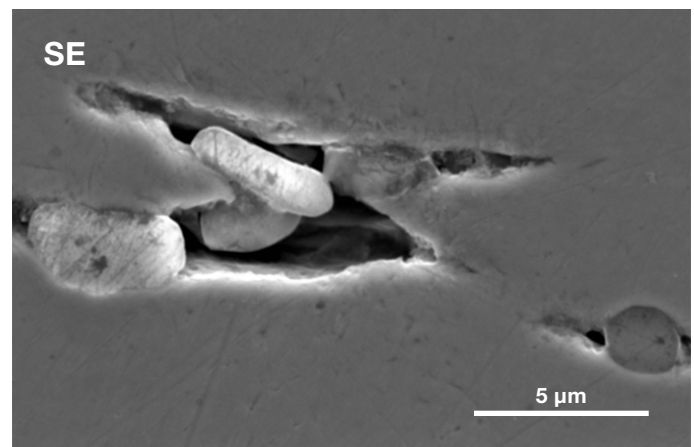
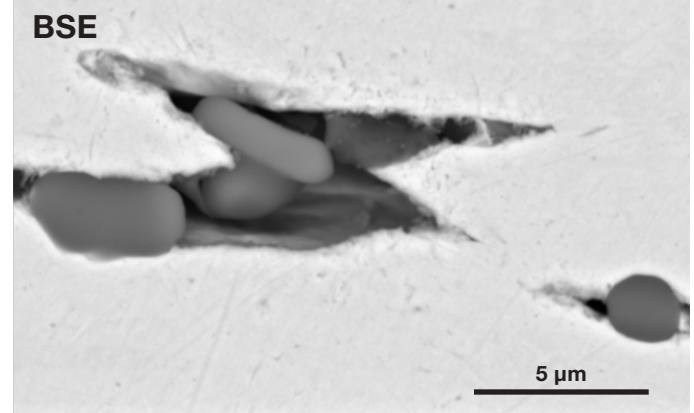
Figure 6. Higher magnification view of the inclusions in the stringer (Acc voltage 15 keV, beam current 0.22 nA, acquisition time 60 s).

Figure 6 highlights some of the inclusions present in the stringer. The top image shows the secondary electron signal, which gives topographical information and shows the presence of voids. Due to the presence of inclusions, voids are often formed during the hot rolling process as the deformed steel surrounding the foreign particles undergoes high tensile stress along the rolling direction.

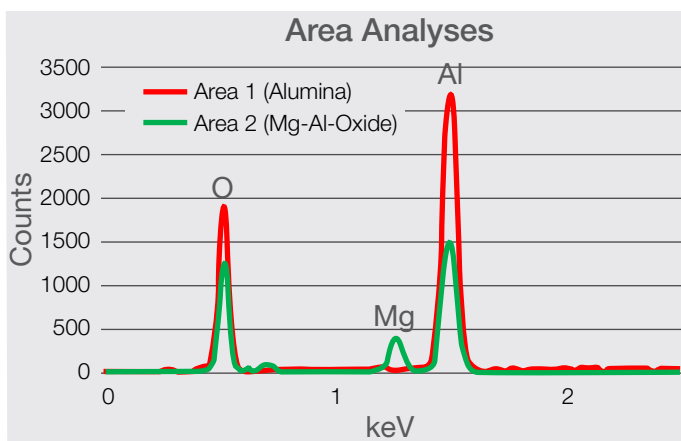
Figure 8. Spectra comparison between the two types of inclusion, showing a clear presence of magnesium ($K\alpha$ at 1.253 keV).

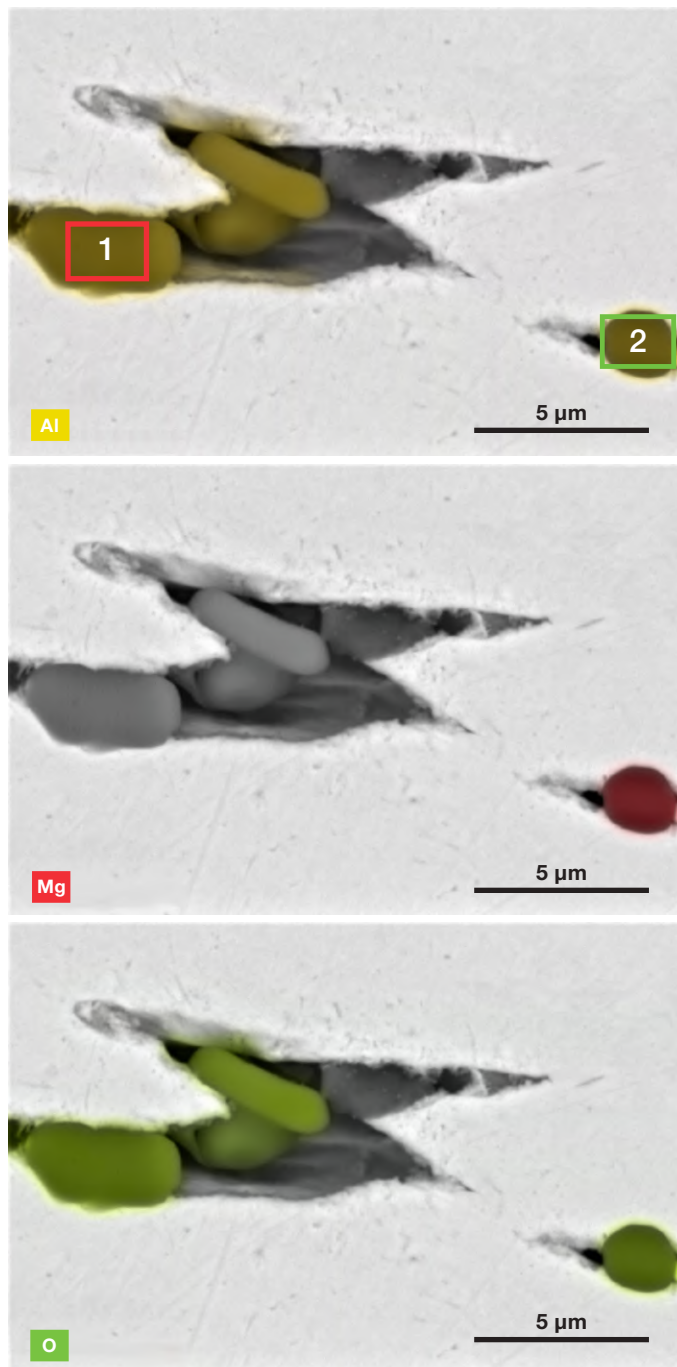
The elements have been selectively activated in order to see their distribution within the inclusions, with no overlap in the coloring. Figure 7 immediately shows non-metallic inclusions, with the left group showing a majority of aluminum and the right inclusion showing magnesium as well. 30-second area analyses on the different types of inclusions have been performed on the areas highlighted in Figure 7. The quantifications obtained from the two areas are reported in Table 1.

The quantification and the ratio between elements suggest the inclusions in the left part of Figure 7, including area 1, are alumina, while the right inclusion is a Mg-Al oxide.

Figure 7. ChemiSEM images (showing Al, Mg, and O distribution, respectively) of the ROI in Figure 6 (Acc voltage 15 keV, beam current 0.22 nA, acquisition time 60 s).
