# Failure analysis of corroded steel surface

## Root cause assessment using the Axia ChemiSEM

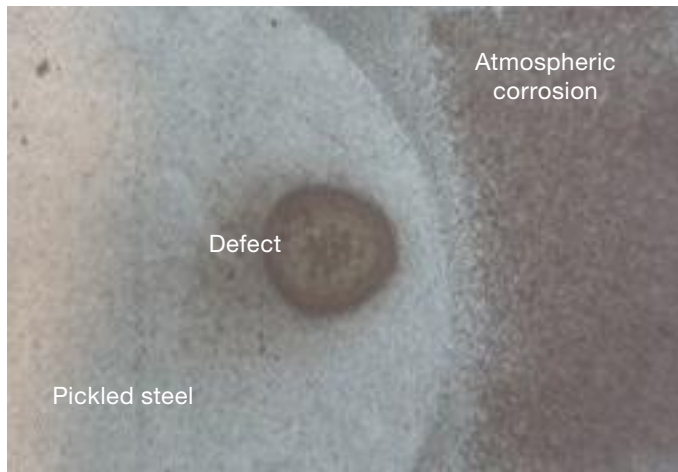
Figure 3 shows a picture of the defective surface. Scanning electron microscopy combined with the chemical information provided by EDS is needed to investigate the defect to assess the presence of morphological abnormalities and to study any possible compositional differences in comparison with the clean surface.

Figure 3. Defective sample.

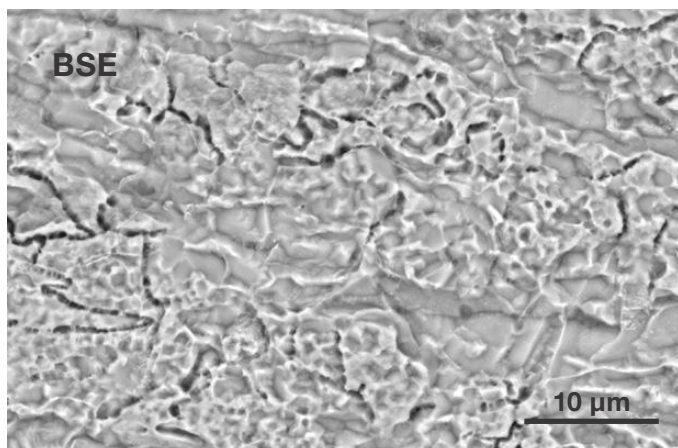
Figure 4. Typical surface of an etched steel (Acc voltage 15 keV, beam current 0.44 nA).

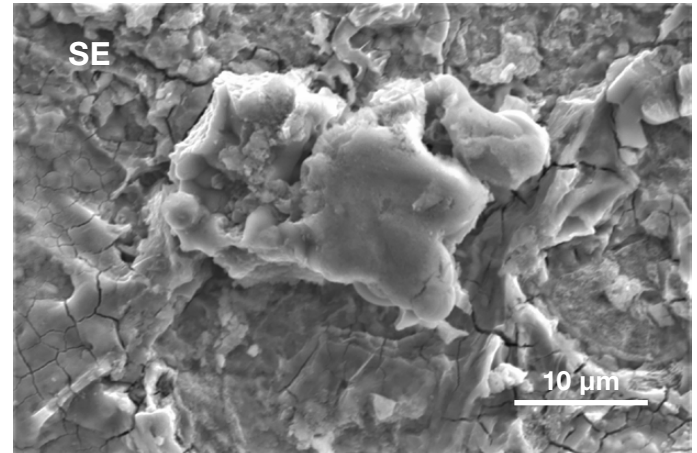
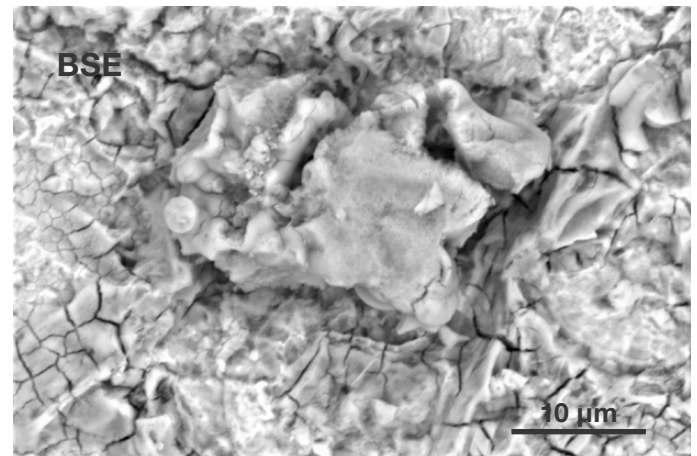
A foreign particle is visible on the analyzed surface. It is also visible in the secondary electron image, where the particle appears to be at a different height than the rest of the surface. However, as we notice from the backscattered electron image, the compositional contrast provided by the conventional SEM imaging is not enough to confirm that it is an unknown object and, most importantly, to disclose its composition.

Figure 5. Secondary electron image (top) acquired inside the defective area. It shows the presence of a particle, higher than the surrounding surface, confirming it can be identified as a foreign object. Backscattered electron image (bottom) shows the compositional contrast (Acc voltage 15 keV, beam current 0.44 nA).

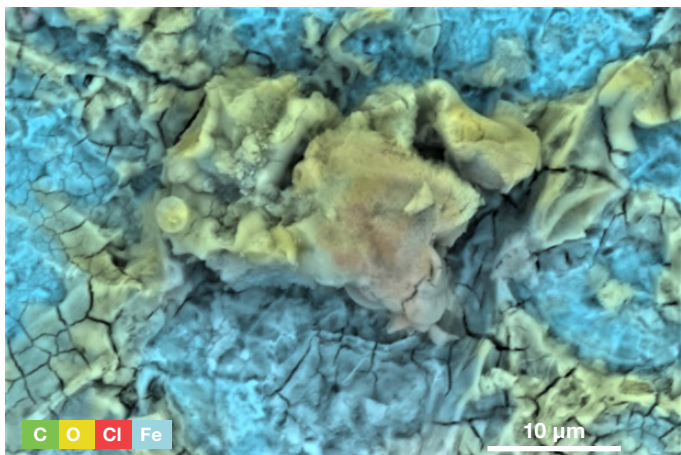
Figure 6. ChemiSEM image of the area displayed in Figure 5 (Acc voltage 15 keV, beam current 0.44 nA, acquisition time 60 s).

The ChemiSEM image in Figure 6 shows the distribution of all the present elements. The presence of iron is expected, while the presence of oxygen highlights where the sample is oxidized. The presence of chlorine, however, is unexpected and needs further investigation. For an instant confirmation of the chlorine distribution, the Axia ChemiSEM allows you to hide certain elements in order to show only the element of interest (Cl in this case).

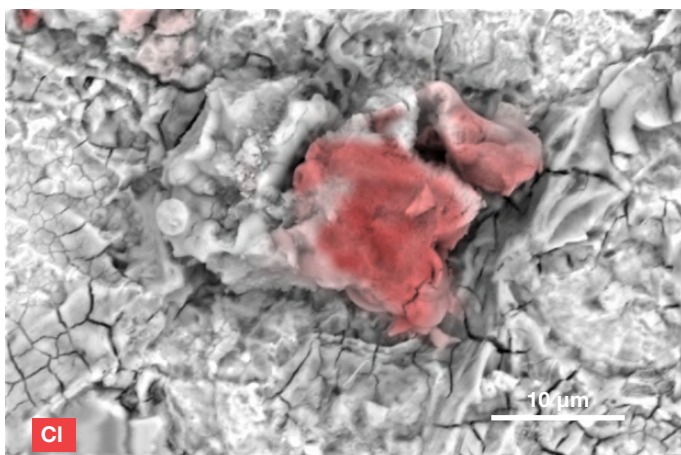
Figure 7. ChemiSEM image of the Cl distribution (Acc voltage 15 keV, beam current 0.44 nA, acquisition time 60 s).

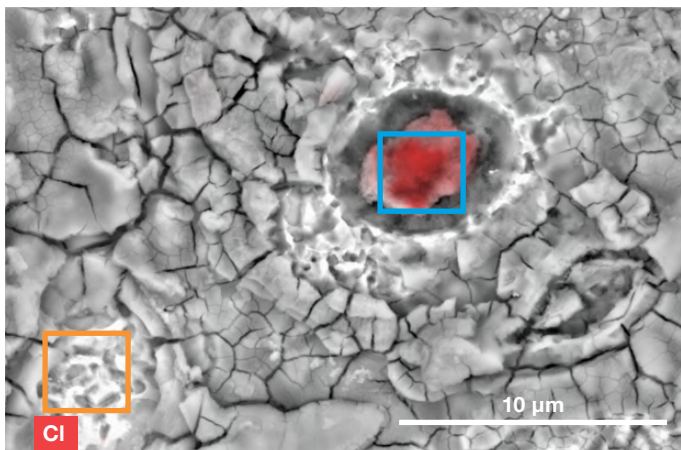
Figure 8. ChemiSEM image showing the two areas used for the region analyses.

Quick area analyses were then executed on another foreign particle and on a clean area of the etched steel (shown in Figure 8) to quantify the contaminants in the stain spot.

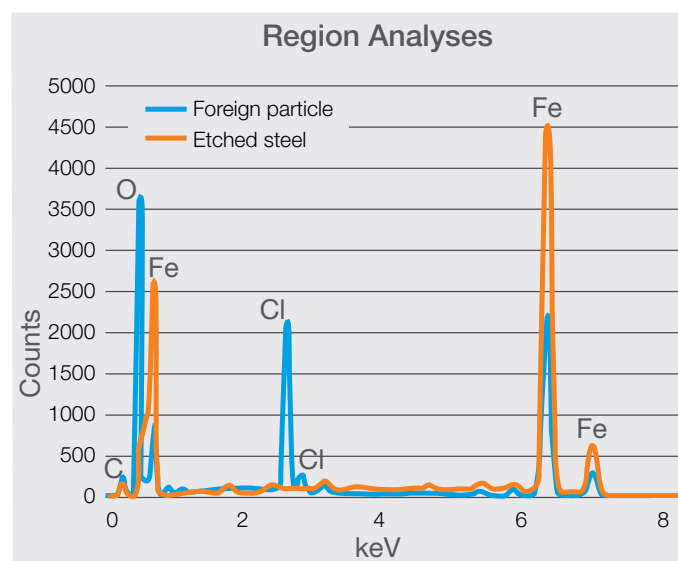
Both the spectrum (presented in Figure 9) and the quantifications (Table 1) confirm a clear difference between the two areas: the amount of oxygen and chlorine measured in the particle support the hypothesis of a foreign object.

Figure 9. Spectra acquired on the foreign particle and on a clean etched steel surface. The comparison shows the presence of the chlorine peaks (the main peak ( $K\alpha$ ) is visible at 2.621 keV) and a higher content of oxygen ( $K\alpha$  at 0.525 keV) in the foreign particle (Acc voltage 15 keV, beam current 0.44 nA, acquisition time 30 s).

The stain spots on the surface contain chlorides in different areas, suggesting that the sample treated with hydrochloric acid may not have been properly washed. Droplets of the pickling acid contacted the surface, causing the stain.
