Characterization of tire fillers with Axia ChemiSEM

A new and more efficient approach to failure analysis

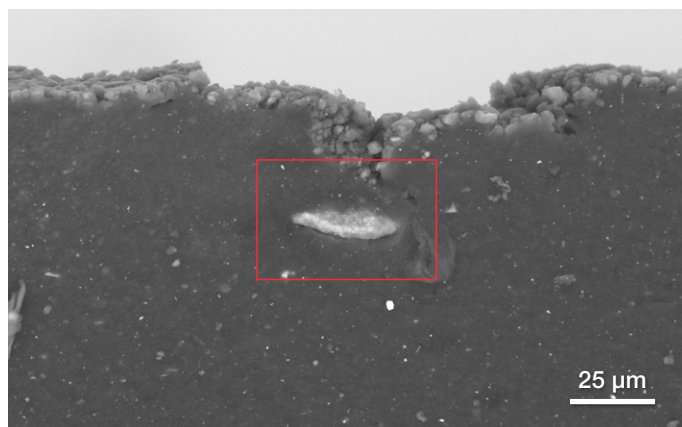
Figure 6. Backscattered electron image showing the position of another type of filler.

Figure 6 below reveals another abundant filler in the tread (upper part of the tire cross section). From the image, it's clear that this filler is very near the external surface of the tire.
