XPS Analysis of a Surface Contamination on a Steel Sample

Author Outi Mustonen, Thermo Fisher Scientific, East Grinstead, West Sussex, UK

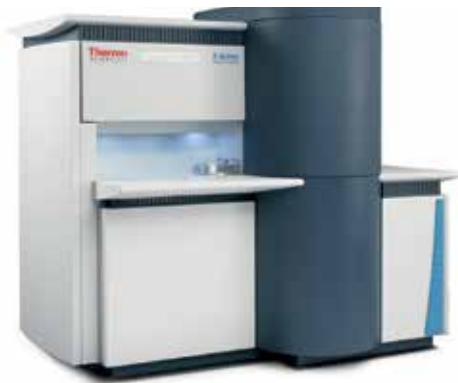
Thermo Scientific K-Alpha XPS
